Ceramic on Ceramic Bearings

Khumrak S, MD¹
email : skbiggumz@gmail.com

Sukree Khumrak, MD¹
Thanasak Yakampor, MD²

¹ Orthopedics Department, Bangkok Hospital Pattaya,
Bangkok Hospital Group, Pattaya, Thailand.

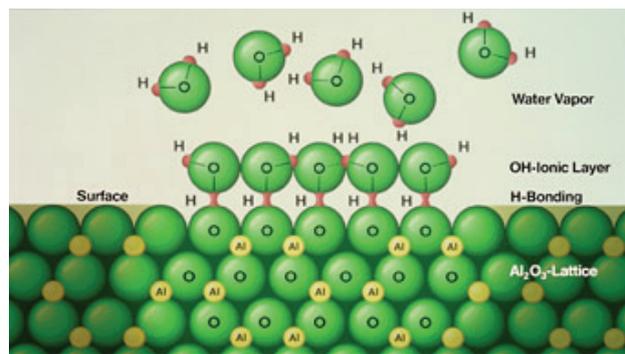
Figure 3: The strong hydrogen bond that forms between ceramic surfaces and synovial fluid give ceramic materials wetting properties that are superior to those of metal and polyethylene.

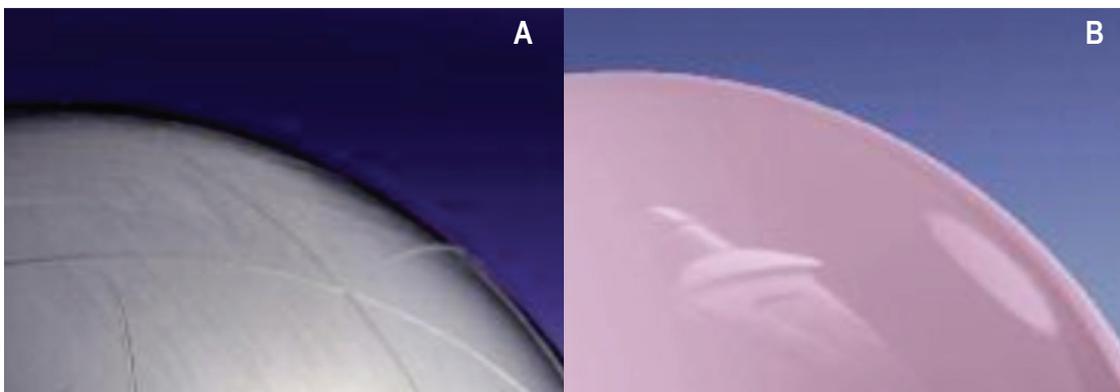
Figure 4 A-B: Shows no scratches on fourth Generation ceramics surface due to high degree of Hardness. (A) Scratched surface increases abrasion on surface of cup liners made of Polyethylene And Metal (CeramTec). (B) Only an unscratched smooth surface of the sort achieved in Fourth Generation ceramics enables optimal wetting, outstanding lubrication and minimal wear (CeramTec)

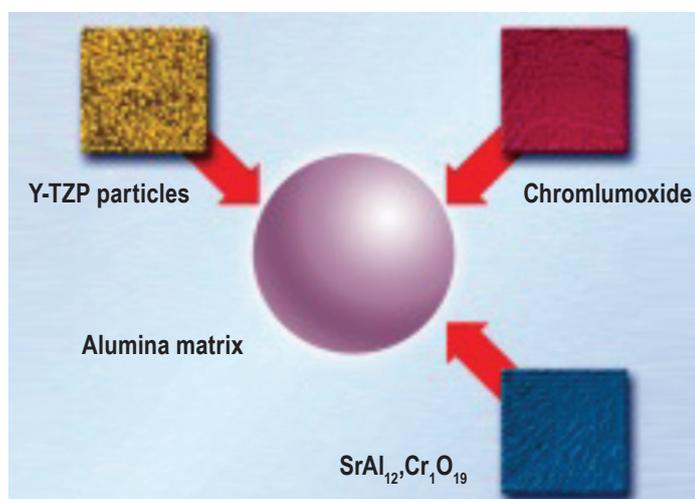
Figure 5: Composition of the alumina matrix composite (CeramTec)

The newest or fourth generation ceramic on ceramic design is Alumina-Matrix-Composite (AMC) or Biolox-Delta (Figure 5) which is composed of Alumina Oxide (approximately 75%), Zirconium Oxide, Chromium Oxide and other oxides. The combination of mechanical properties

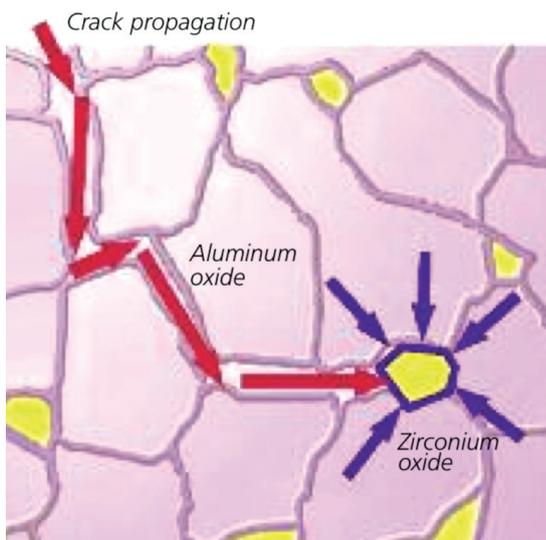
Figure 6: The principle of conversion reinforcement: Zirconium oxide particles act like airbags by absorbing impacting forces. (CeramTec)

The first toughening mechanism is dispersion of nano-sized, yttria-stabilized tetragonal zirconia particles in a stable, alumina matrix. These particles will be homogeneously distributed and produce local pressure peaks in the area of crack which counteracts crack propagation and works like the airbag system in cars. (Figure 6)

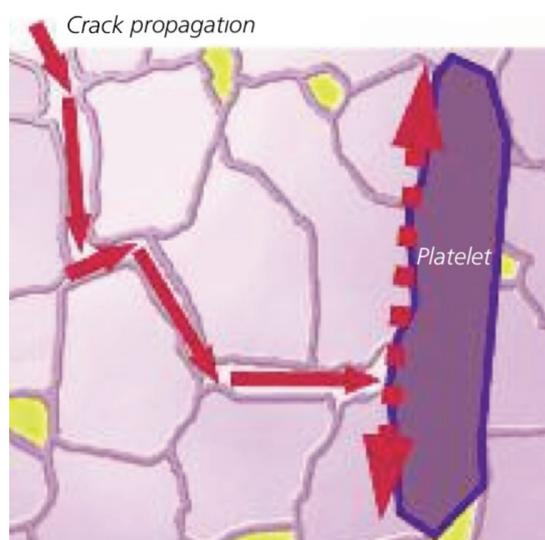
Figure 7: The principle of platelet reinforcement: Platelet-shaped crystals block the propagation of cracks and thereby increase overall strength.

The second strengthening mechanism is the result of in situ formation of platelet-shaped crystals in the oxide mixture. These platelets prevent cracking and crack propagation by deflecting the crack path and neutralizing crack energy. (Figure 7)

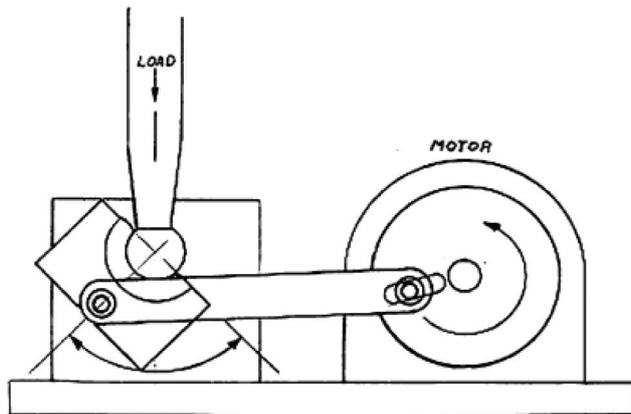
Figure 8: A diagram of the custom-made testing device hip simulator

In 2009, Chevillotte et al.²⁰ reported a biomechanical in vitro study of COC bearings surface which intended to identify the potential contributing factors of Hip Squeaking. They used a custom-made hip simulator to assess in vitro hip squeaking (Figure 8, 9). All Acetabulum Components were positioned in 45 degrees abduction and 20 degrees of anteversion. Eight conditions in two separate situations were applied to testing (Table 2 and Table 3).

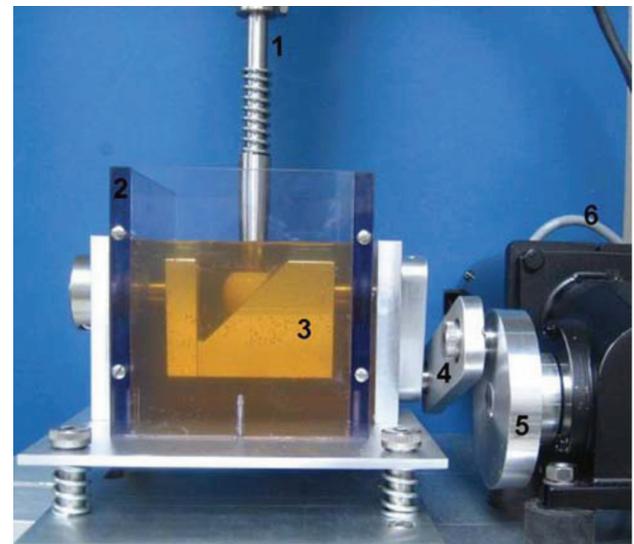
Figure 9: A photograph of the custom-made device is shown.
 1 = Servo hydraulic testing machine
 2 = box
 3 = rotating table
 4 = bar linkage
 5 = rotating jig
 6 = motor

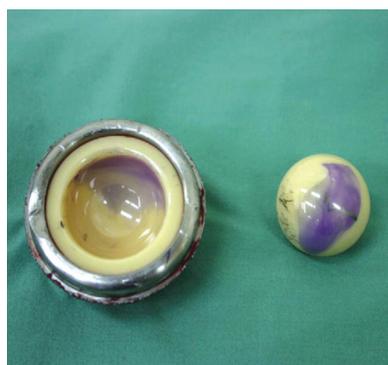
Figure 10: Third generation alumina ceramic-on-ceramic bearings with well fixed and well positioned acetabular components

Stripe wear is the term used to describe the long, narrow area of damage seen on some femoral heads retrieved from alumina COC hip bearing couples. Stripe wear has been reported in first and second generation alumina bearings²³ However, there were also reports of stripe wear in third-generation alumina ceramic-on-ceramic bearings with well fixed and well positioned acetabular components.²⁴ (Figure 10)

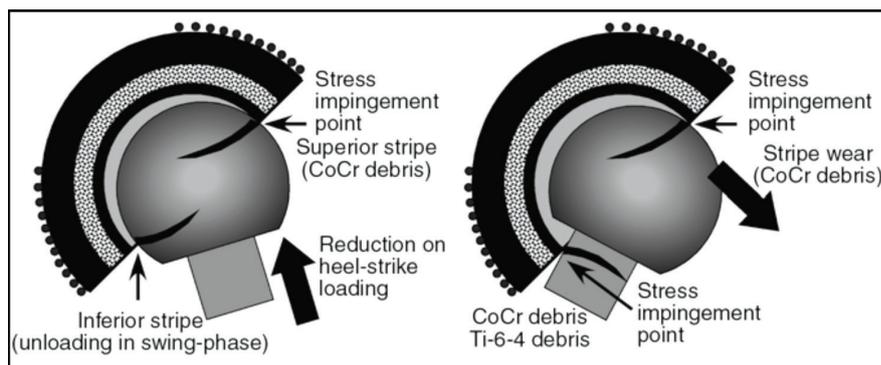
Figure 11: During forced reduction at heel-strike, a superior and somewhat equatorial stripe would then be created on the head and the mating cup rim

Some literature reported produce stripe wear was due to edge effects in rigid ceramic-on-ceramic total hip arthroplasty.²⁶⁻²⁸ When the hip was slightly subluxated during the swing phase of gait, the cup edge might create an inferior and somewhat equatorial stripe on the femoral head along with a circumferential stripe along the cup rim. During forced reduction at heel-strike, a superior and somewhat equatorial stripe would then be created on the head and the mating cup rim.¹⁹(Figure 11).

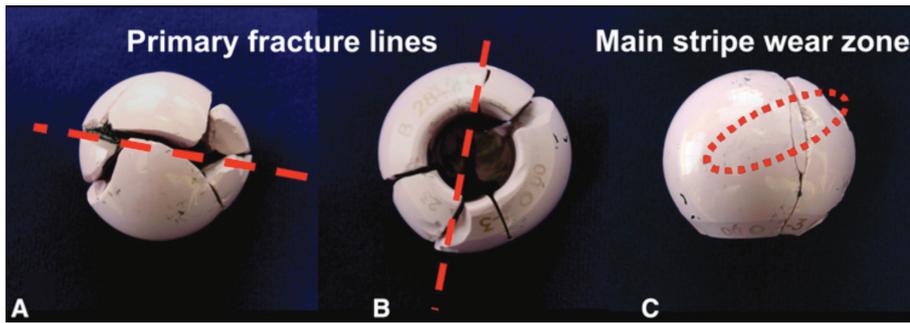
Figure 12A-C: Overview of fracture fragment from a 28-mm delta from (A) polar view, (B) view of the base, and (C) side view of the stripe wear zone. The dominant fracture plane is indicated by dashed lines in the polar and basal views. The large stripe wear zone crosses over three of the fragments at the angle indicated by the dashed ellipse on the side view

of alumina femoral head fractures has decreased. The rate of fracture of femoral heads with this material is reported by the manufacturer to be 1 in 50,000.³⁷ In 2010, Lombardi et al.³⁸ reported atraumatic fracture of AMC femoral head. The analysis of the fractured alumina matrix composite femoral head demonstrated the surface roughness increased minimally from new condition (3 nm) to the main wear zone (5 nm) (Figure 12, 13).

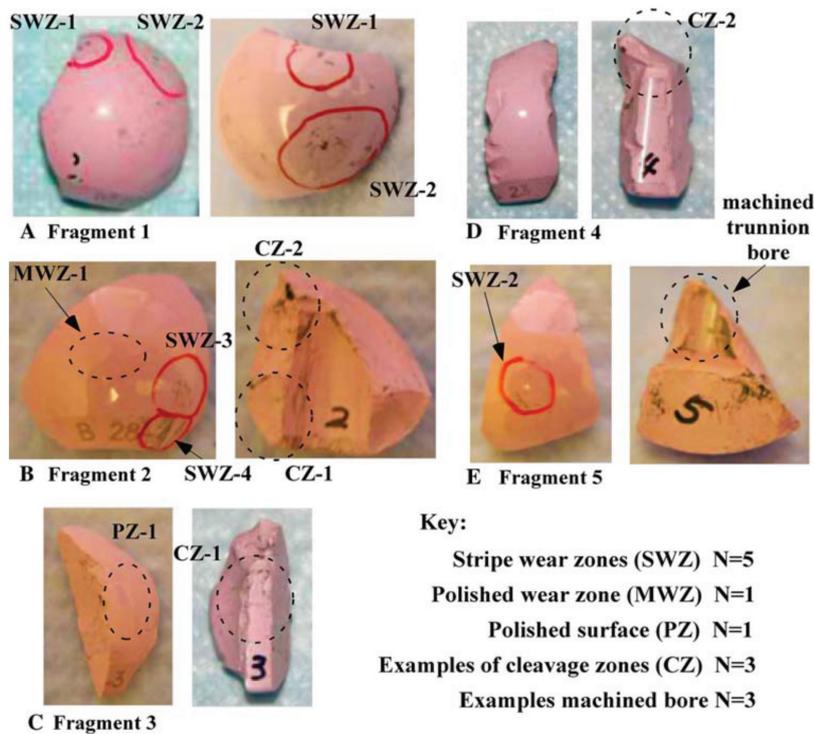
Figure 13A-E: Photographs show five of the largest of seven fragments (A-E) from a fractured 28 mm 'Delta' ball. The circles indicate site of analysis for polished main wear zone (MWZ), stripe wear zones (SWZ), metal contamination, machined taper bore and fracture cleavage regions (CZ).

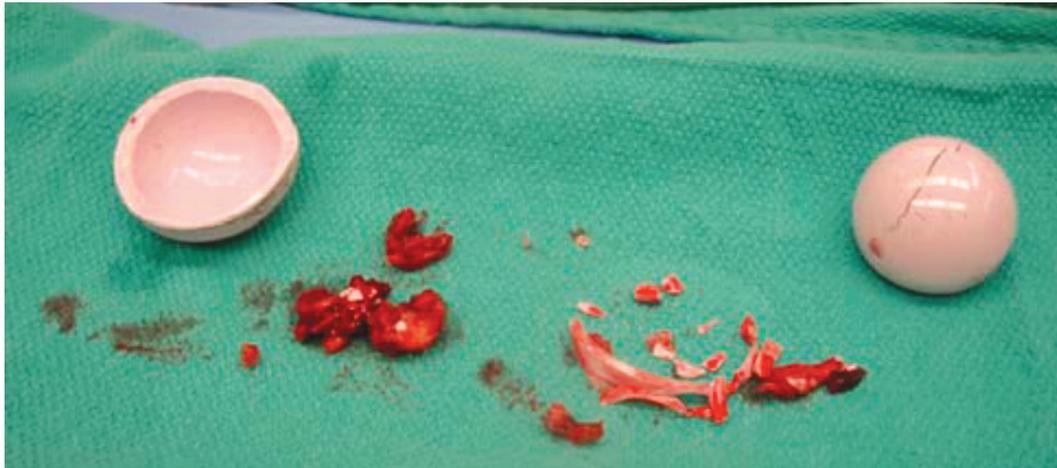
Figure 14: The retrieved liner and head show the fractured rim of the liner and ceramic fragments retrieved from the wound.

Hamilton et al.³⁹ also reported the overall rate of post-operative ceramic liner fracture was 1.1% (two of 177). The authors presumes most liners failed as a result of eccentric or incomplete seating of the modular ceramic liner within the metal acetabular shell. Improper positioning and impaction may generate uncontrolled peak stresses in the ceramic, which may lead to fracture⁴⁰ (Figure 14).

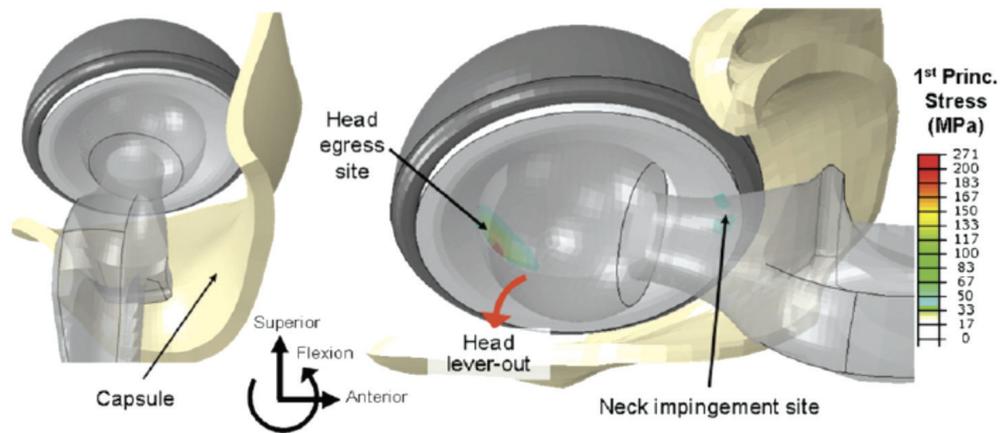
Figure 15: Total hip arthroplasty impingement global FE model. Challenge motions began in full extension (left) and progressed through the prescribed hip angulation sequence, resulting in impingement (right).

obesity.⁴¹⁻⁴³ Fractures apparently due to component impingement were explored.^{40,44-46} There were reports that ceramics are vulnerable to fracture due to impact and from stress concentrations (point and line loading) such as those associated with impingement-subluxation.⁴⁷ The risk of ceramic femoral head fracture during impingement-subluxation was found to be highly site specific owing to the greatly higher tensile stress at the (edge-loading) egress site compared with that from neck-on-liner impingement (Figure 15).

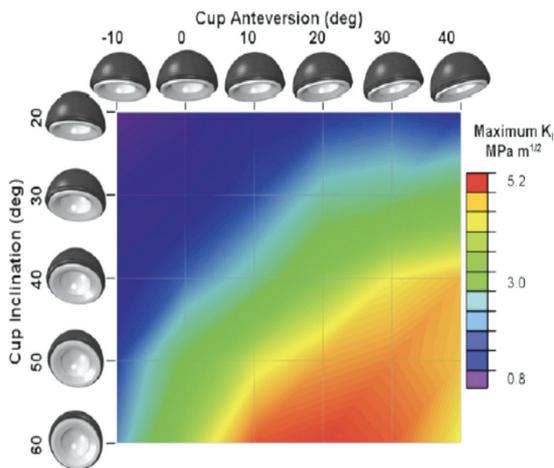
Figure 16: Computed values of temporal-spatial maximum KI for the stoop challenge demonstrating fracture propensity sensitivity to both cup inclination and anteverision.

Another interesting factor is cup position. The biomechanical study showed ceramic cup fracture propensity is presumably very sensitive to surgical cup positioning. Higher cup inclination and/ or cup anteverision angles gave rise to the higher values of tensile stress if/when subluxation-associated edge loading occurred (Figure 16). The study of the stress on cup position concluded that increased cup inclination and increased anteverision were found to elevate fracture risk. It is reasonable to avoid impingement-subluxation, higher cup inclination and cup anteverision of ceramic bearing to reduce risk of ceramic bearing fracture.
